# Phase One Environmental Site Assessment

700 Acres

State of Oregon's Mill Creek District Surplus Property  
Salem, Oregon

July 2003  
Project #: 16912.000

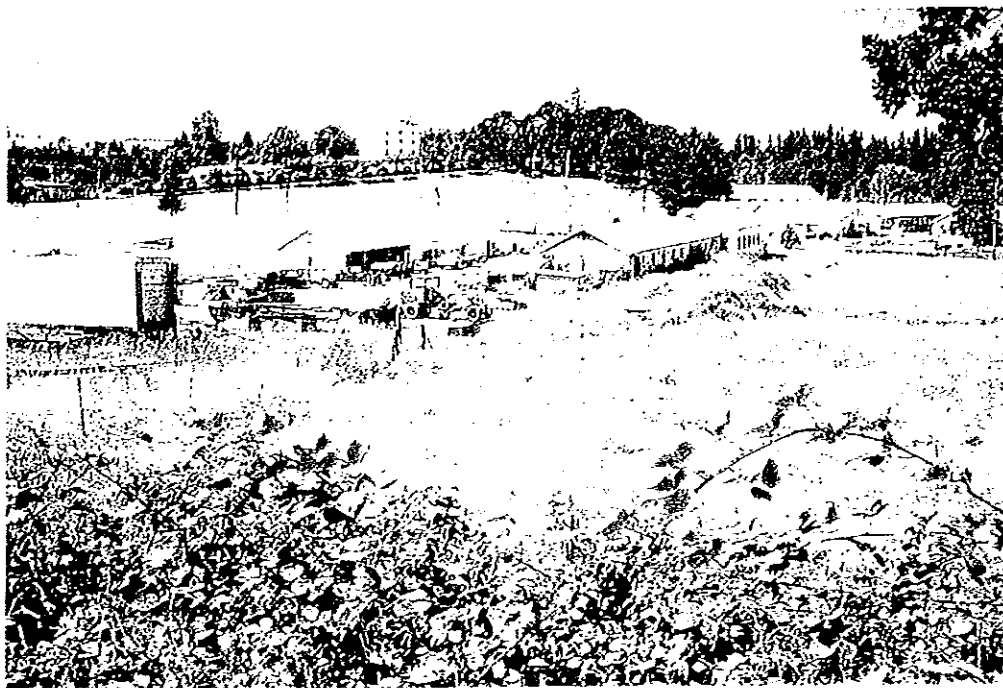
PHOTO 1: View from Pheasant Hill (southern subject property) looking south toward the buildings that front Turner Road SE. The Mill Creek Correctional Facility (MCCF) is seen in the background.

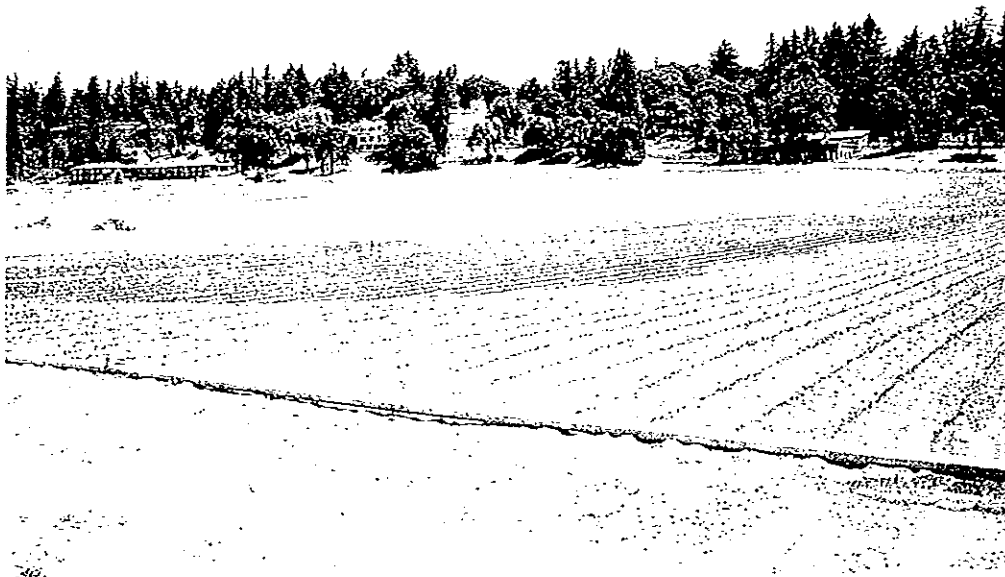
PHOTO 2: View looking east from southern portion of the subject property. The Western Baptist College campus is seen in the background of the photograph.

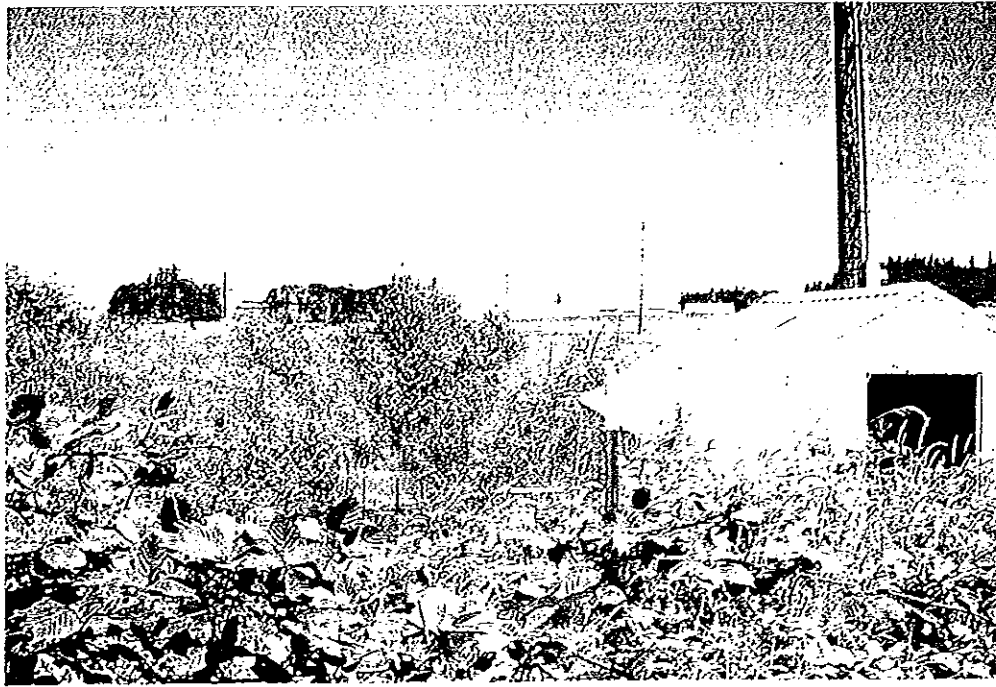
PHOTO 3: Photograph taken looking northeast along the irrigation and drainage canal, one of two that are oriented east-west across the subject property. A pump house is seen at right.

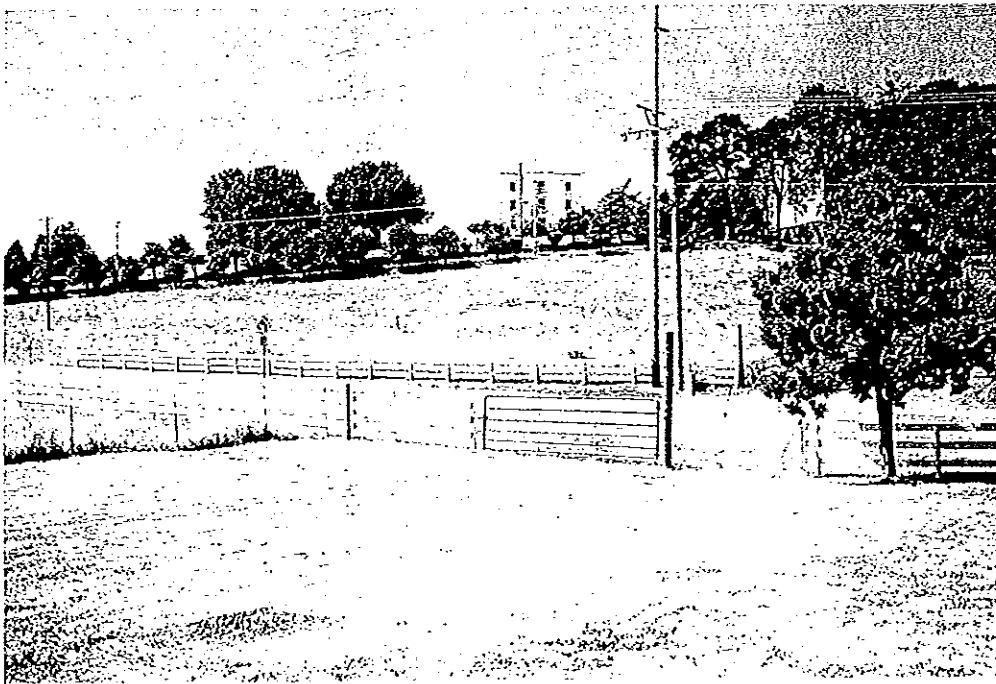
PHOTO 4: Photograph taken looking southeast toward MCCF administration and dormitory building adjoining the subject property across Turner Road SE.

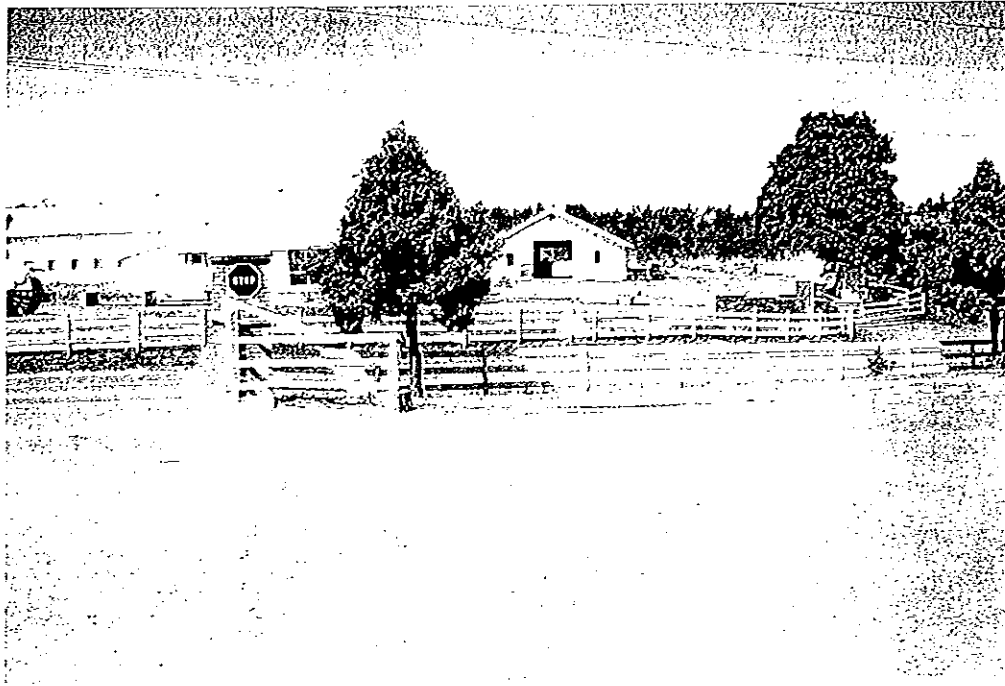
PHOTO 5: View looking south at the entry to the subject property from Turner Road SE. The south-adjointing MCCF dairy is seen in the background.

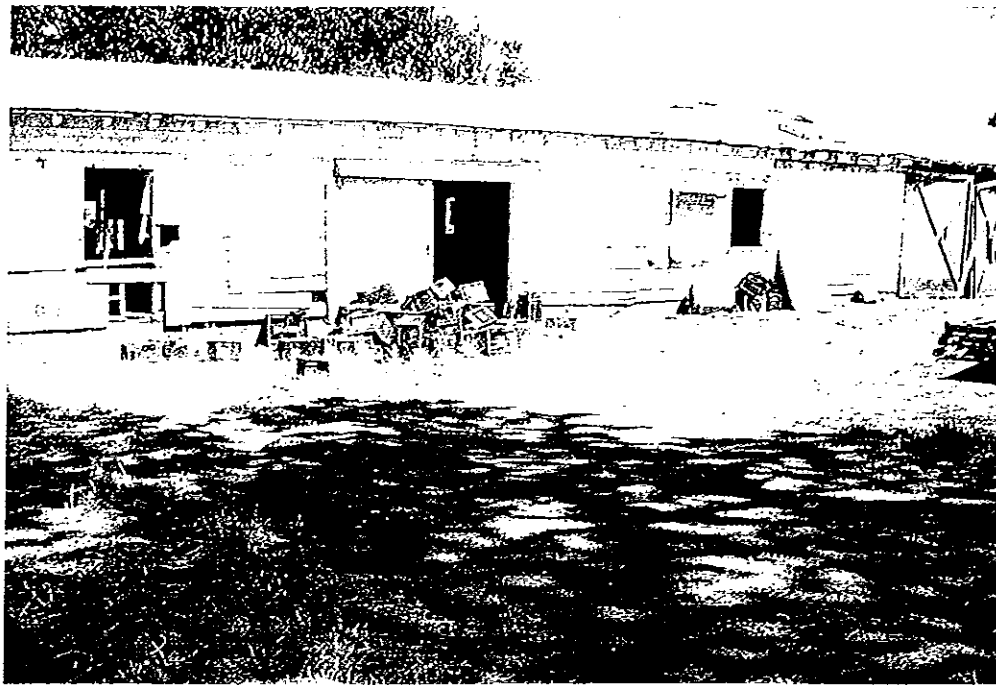
PHOTO 7: Livestock building No. C020, one of several buildings located on Pheasant Hill and formerly used to raise fowl and calves.

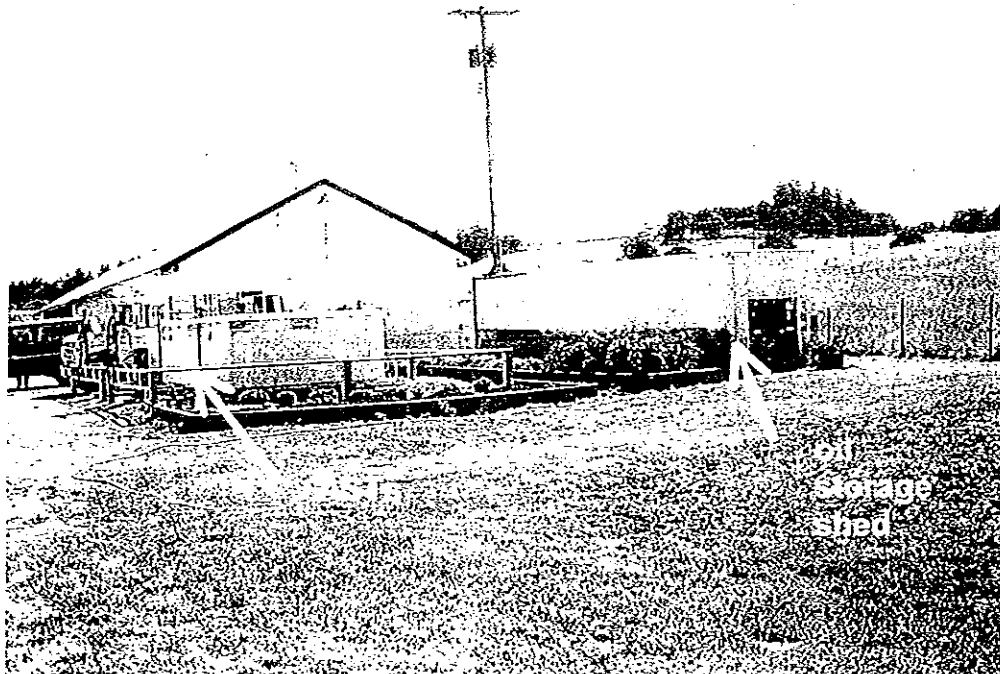
PHOTO 8: Office, parts storage and maintenance shop building. Two 2,000-gallon ASTs (gasoline and diesel) and the oil storage shed are observed in the photograph.

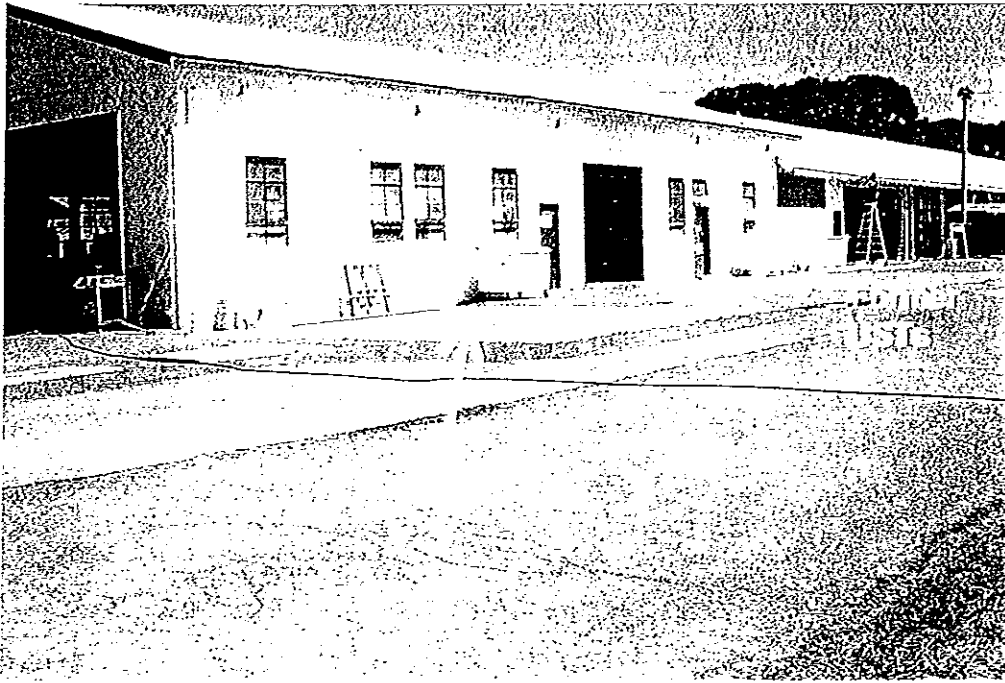
PHOTO 9: View of the machine and welding shop building looking north. The concrete pad is a recently installed oil/water separator system. Monitoring wells are located adjacent to the building.

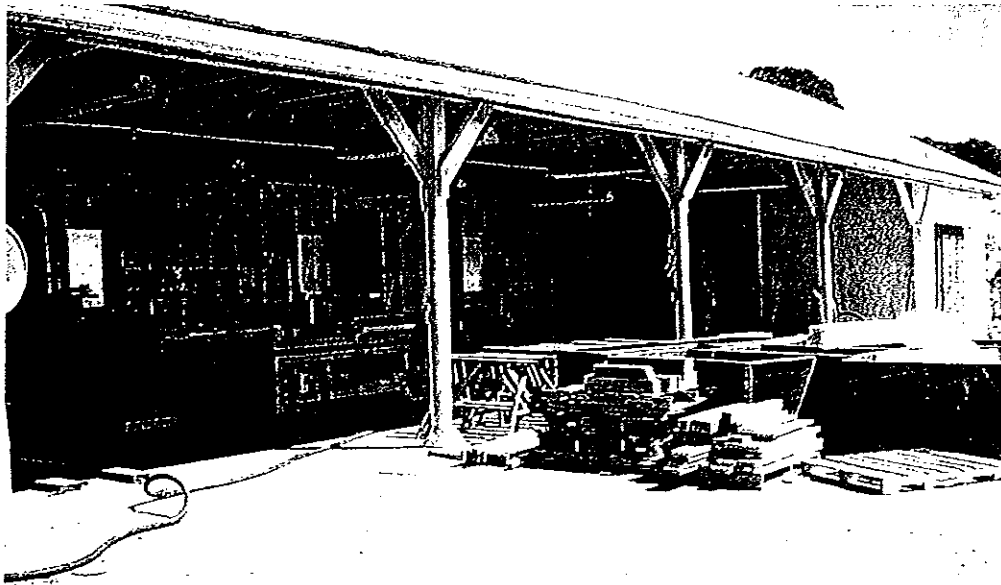
PHOTO 11: Covered wood shop and metal storage area located adjacent to the machine and welding shops. The enclosed area of the building is used as a paint booth.

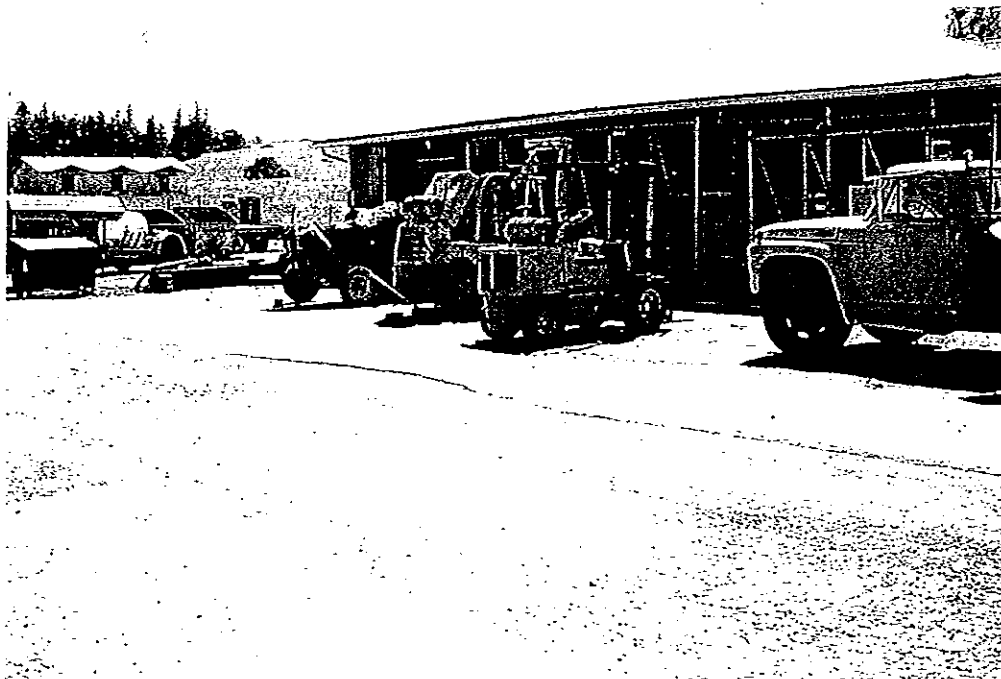
PHOTO 12: Vehicle maintenance building located across from the paint booth and storage area. The fertilizer storage building is seen in the upper left background of the photograph.

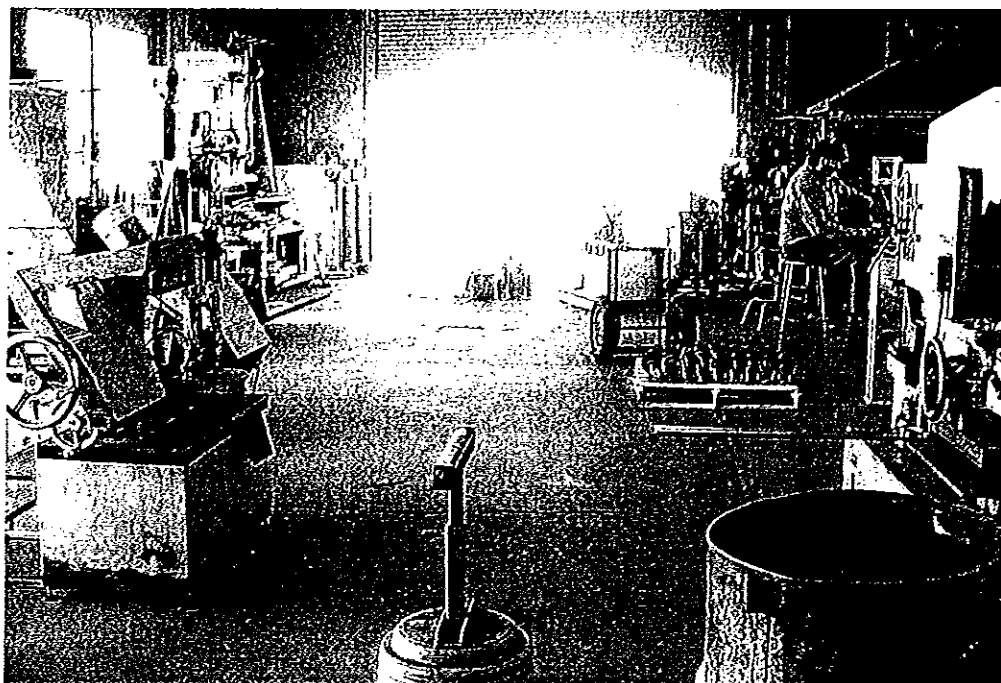
PHOTO 13. Interior view of the machine shop looking south toward the garage door at the south end of the building.

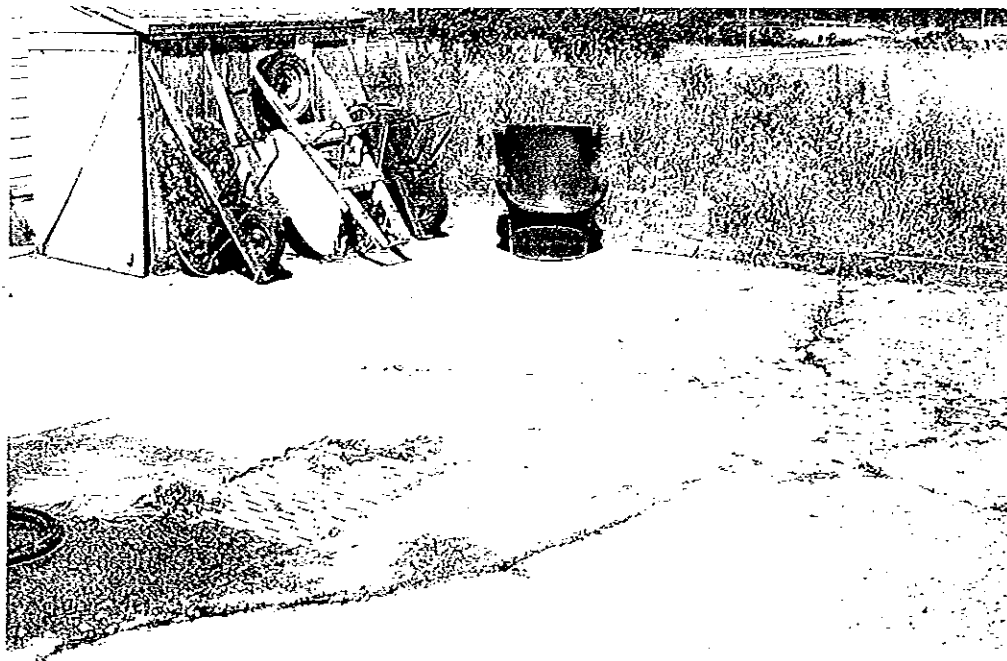
Minor petroleum staining was noted near the maintenance shop trench drain. No staining was noted adjacent to the wash pad catch basin located near the AST shed. No other floor drains or catch basins were observed in the vicinity of these materials.

PHOTO 14: Concrete wash pad and catch basin located on the north side of the paint booth. View is to the west-southwest.

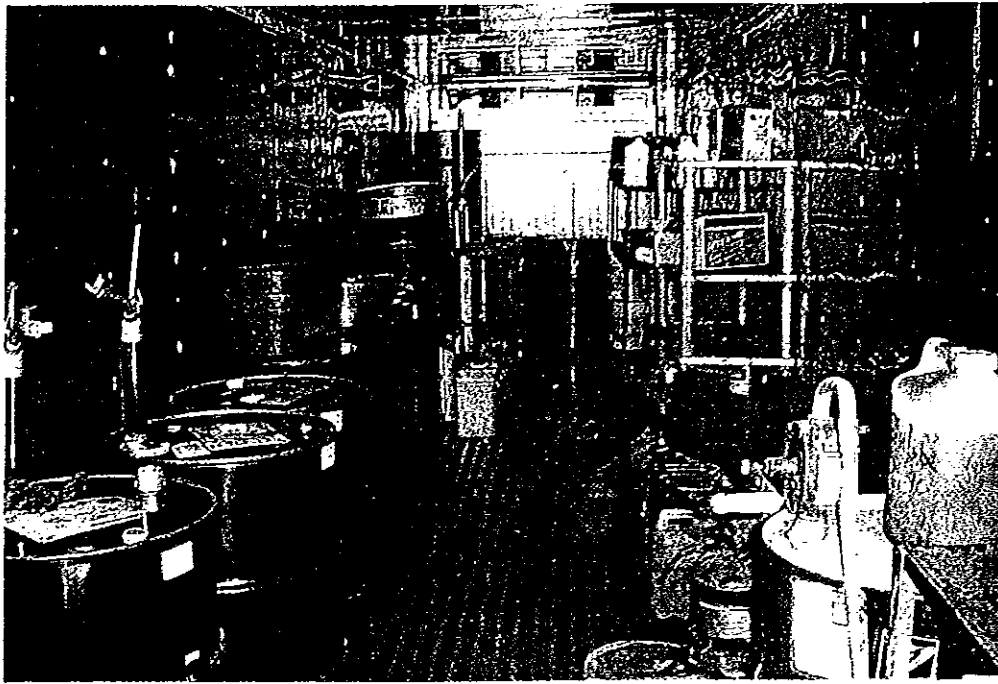
PHOTO 15: Fifty-five gallon drums and various containers located in the oil shed south of the office and east of the ASTs.

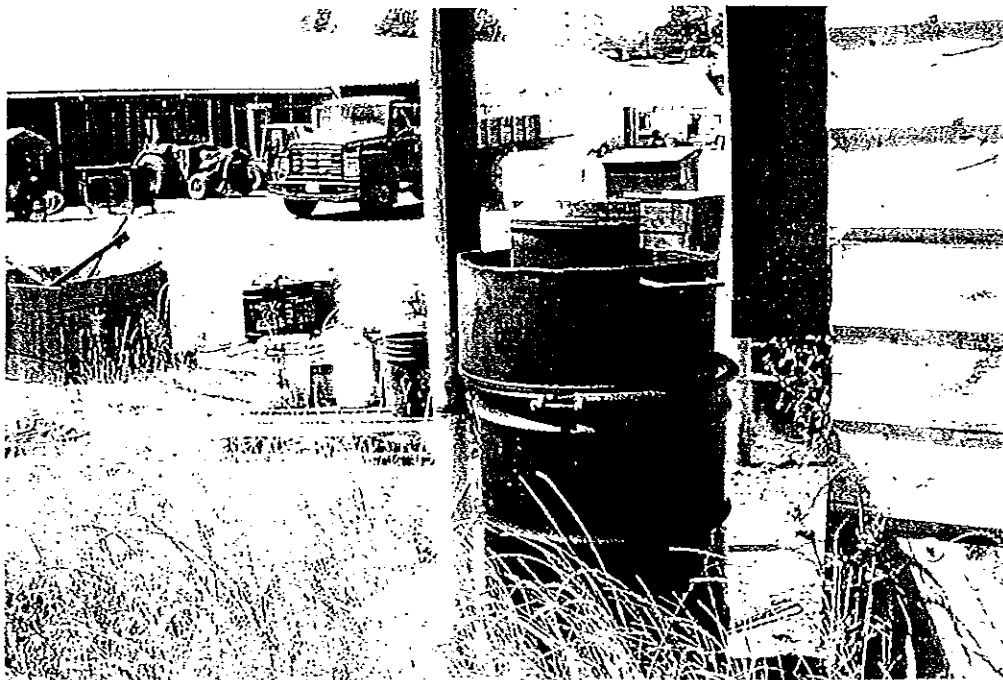
PHOTO 16: Waste oil collection pans and 55-gallon drum, which appears to be used to transfer oil into the enclosed 1,000-gallon waste oil AST (right; see Photo 17).

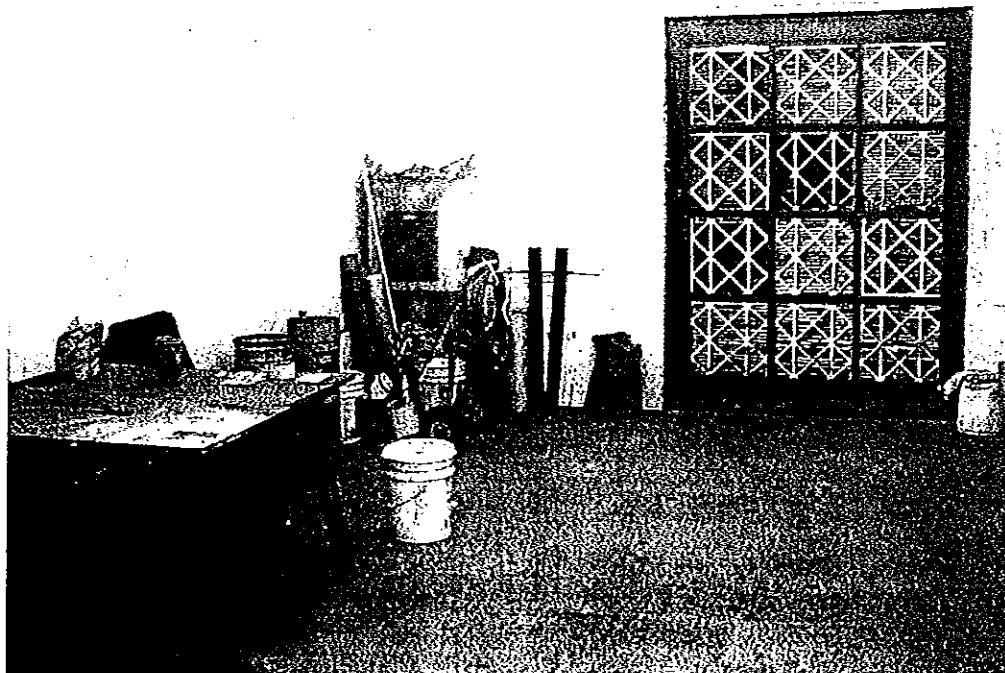
PHOTO 18: Interior view of paint booth on the subject property.

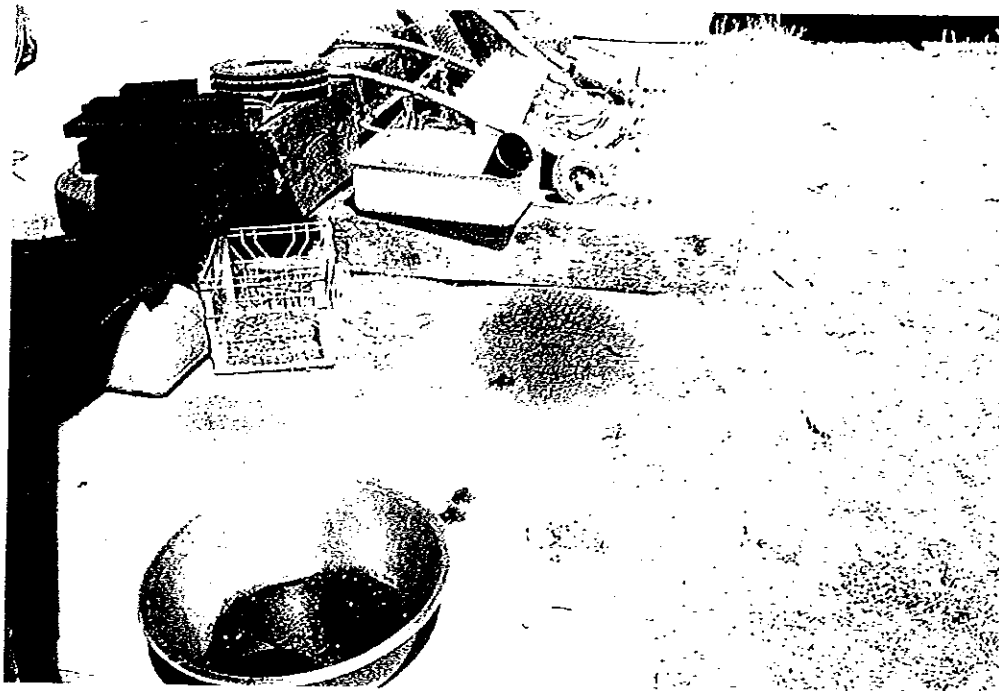
PHOTO 19: Observed oil collection containers located adjacent to the trench drain that extends across the asphalt and gravel surface between the paint booth and vehicle maintenance shop.

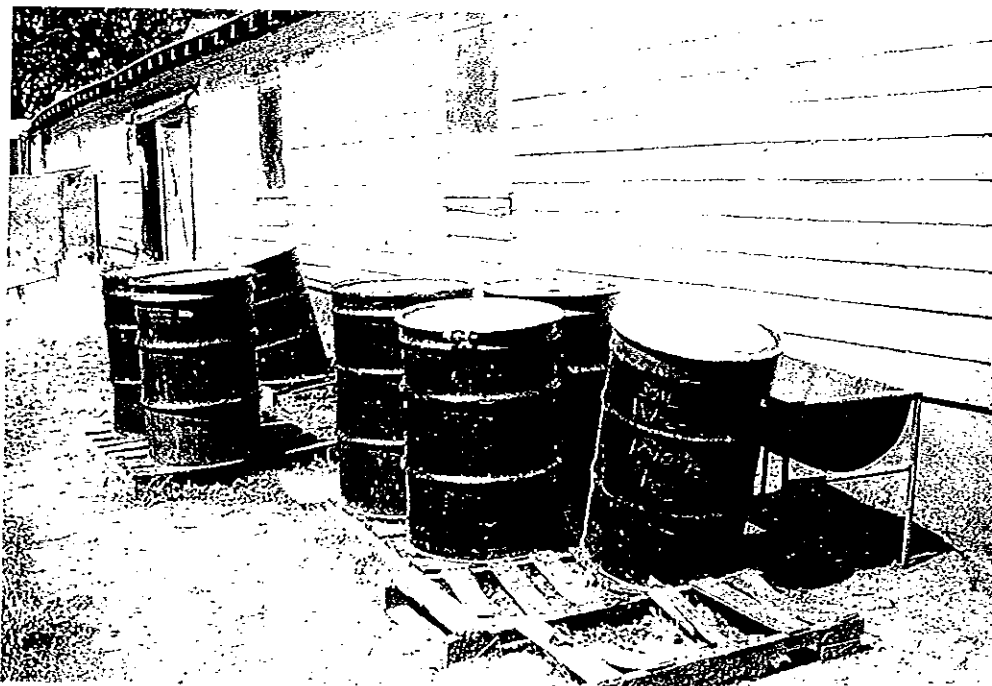
PHOTO 20: Drum storage area located on the southeast corner of building C021. The drums contain soil cuttings and groundwater from onsite testing completed by PBS.

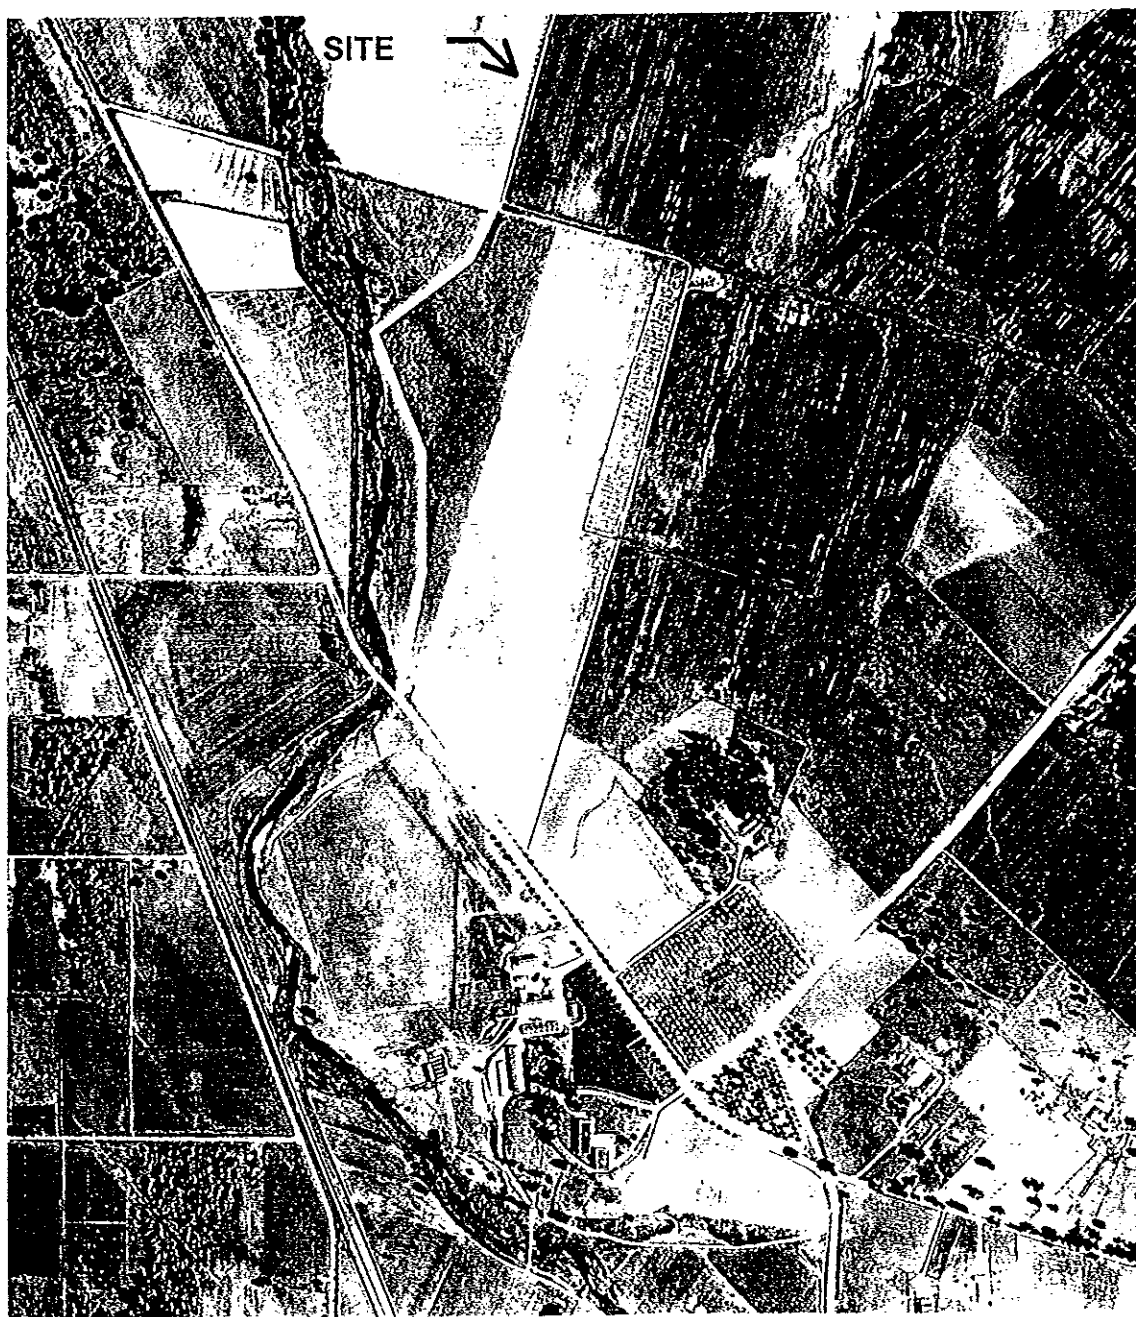
1948 Aerial Photograph

1948: This photograph covers the southern portion of the site. No coverage of the northern portion is shown. New buildings appear to be present east of the structures shown on the 1936 photograph. A large multi-building complex is shown where the present-day Mill Creek Correctional Facility is located. Farm and/or residential buildings are present on southeast-adjointing properties and a small orchard or nursery adjoins the southern tip of the property. No other significant changes are noted to the subject property or adjoining sites.

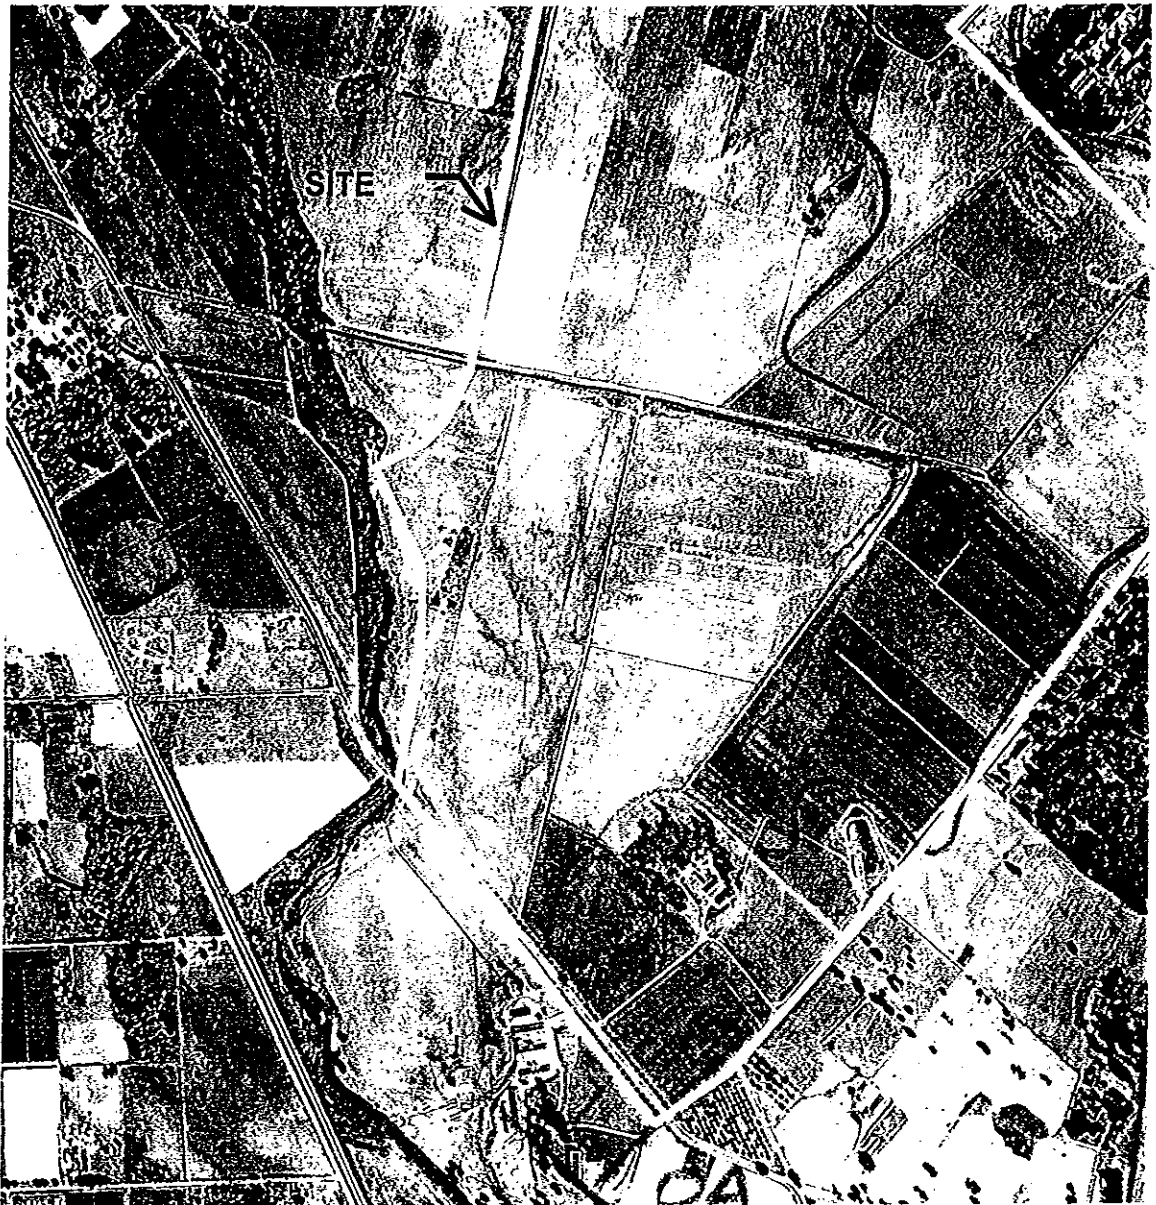
1955 Aerial Photograph

1955: No significant changes are noted to the subject property or adjoining sites. Black markings on the photograph appear to be drawn on by a wax pencil or pen.

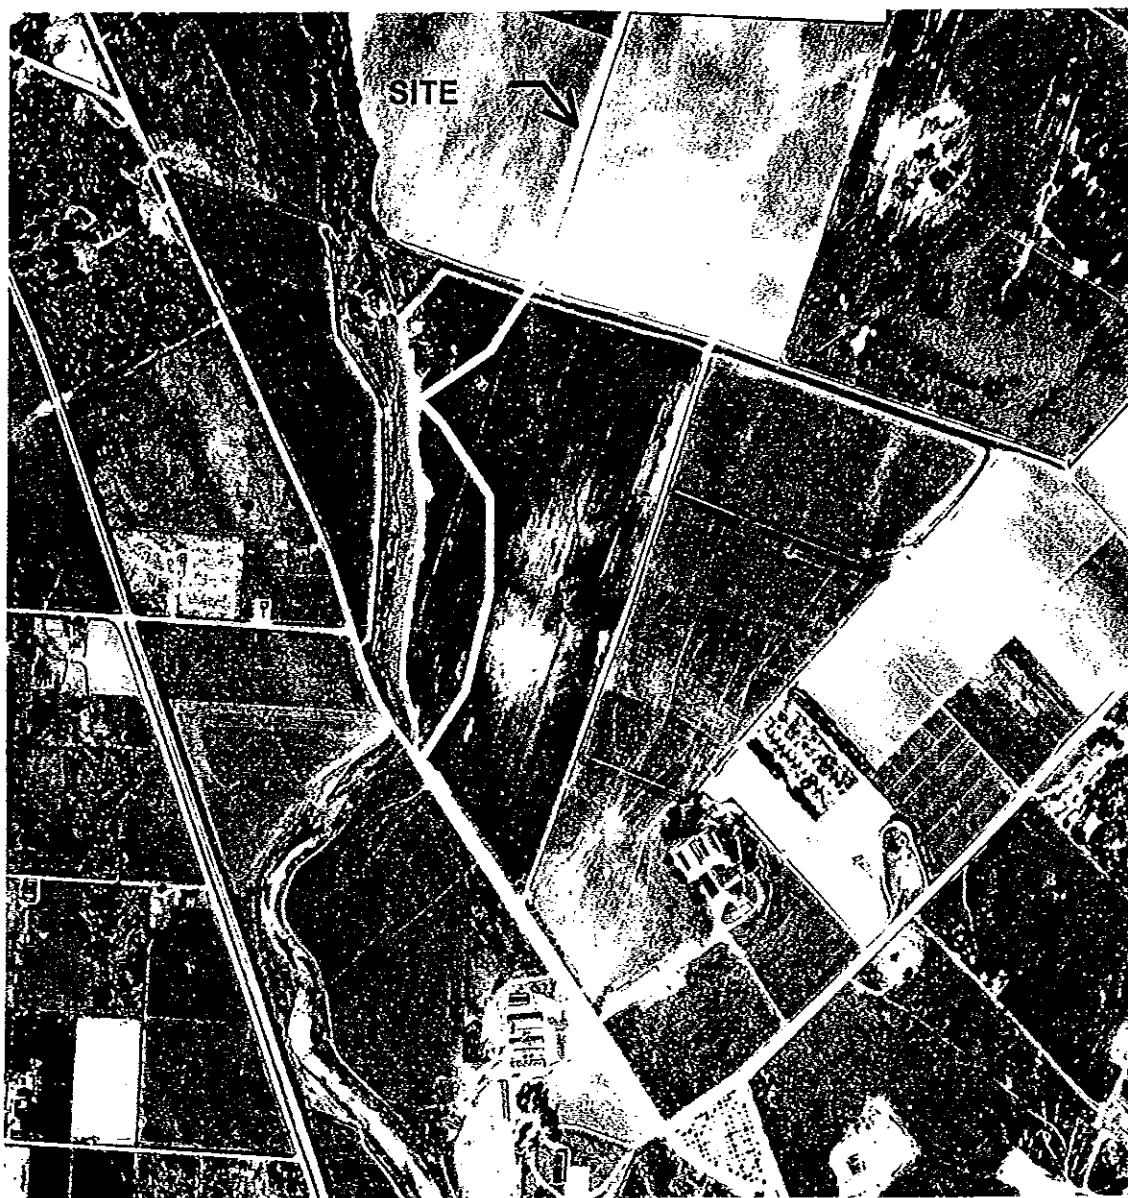
1963 Aerial Photograph

1963: Several new buildings are seen on the southern portion of the site in the location of the present machine shop, welding, maintenance and office buildings that front Turner Road SE. Portions of Mill Creek appear to be channeled or modified to facilitate irrigation/drainage on the subject property. Development is noted on west nearby properties.

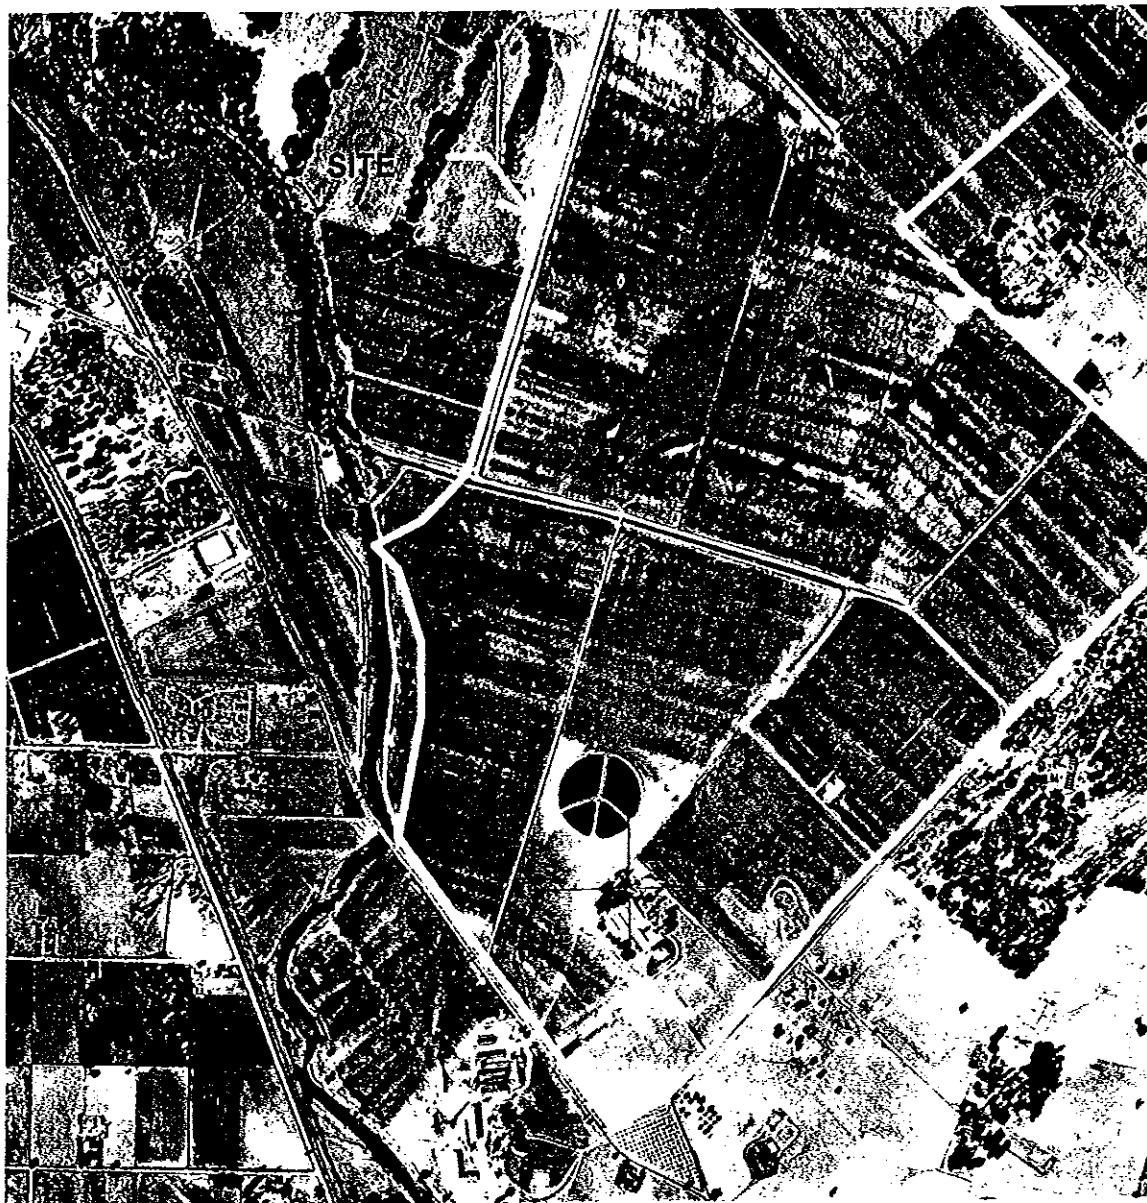
1970 Aerial Photograph

1970: A partitioned pond is present north of the site buildings and two new smaller buildings are seen to the west and southeast. Additional development is seen on nearby properties west of Mill Creek. No other significant changes are noted to the subject property or adjoining sites.

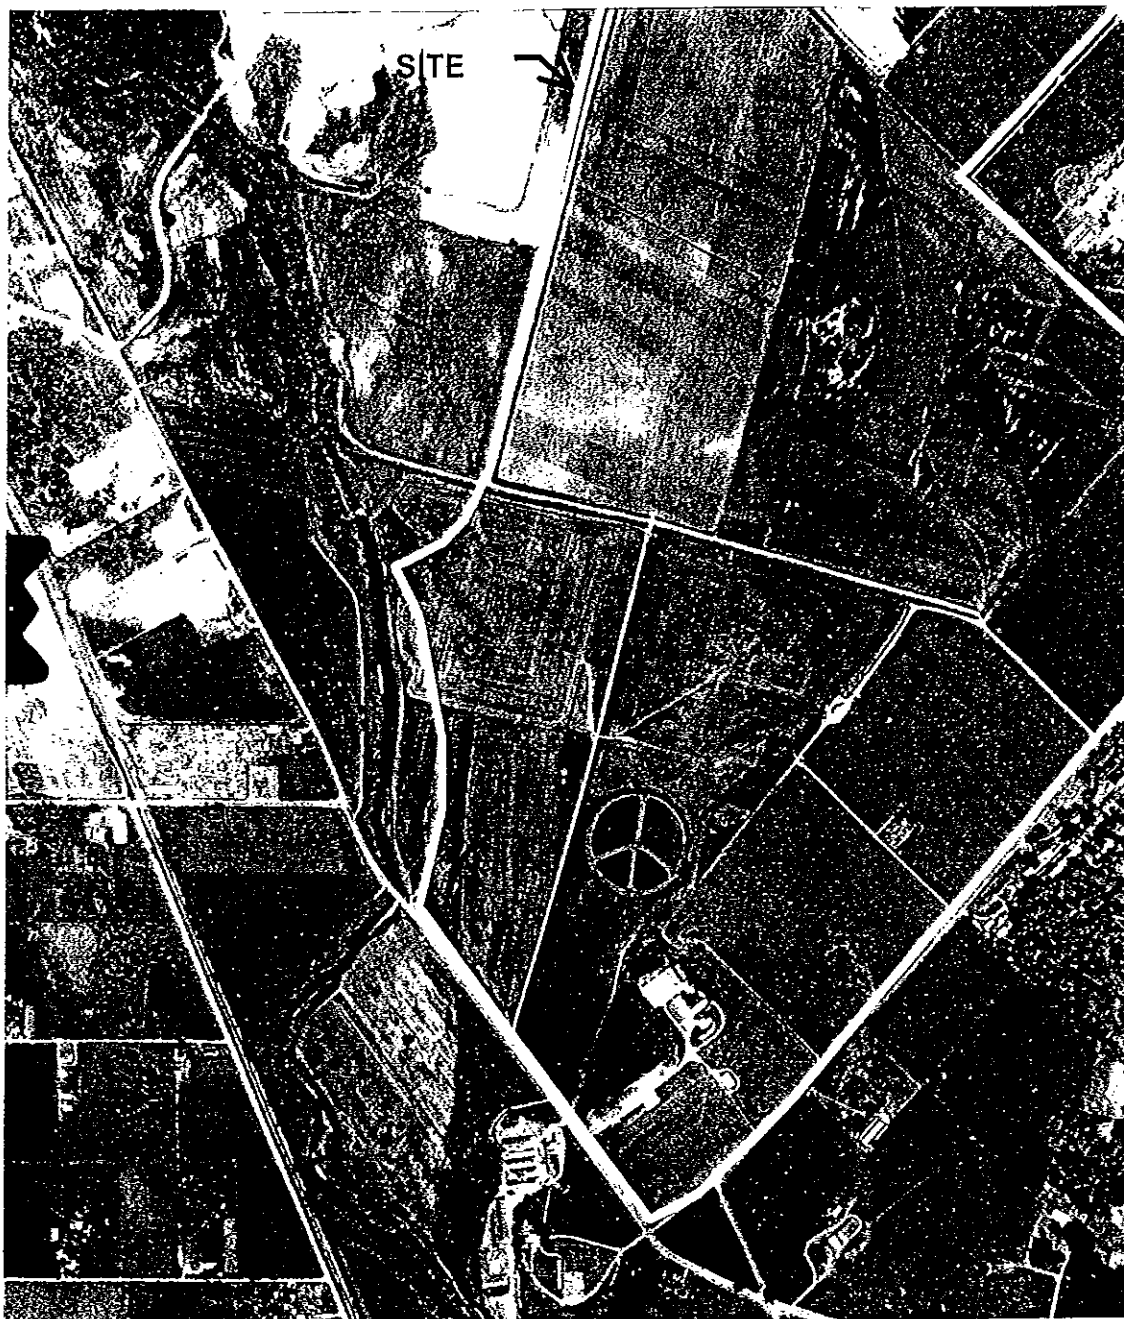
1976 Aerial Photograph

1976: No significant changes are noted to the subject property. Clearing is seen on the west adjoining sand and gravel business property and continued development is seen on nearby properties along Turner Road NE. No other significant changes are noted to adjoining sites.

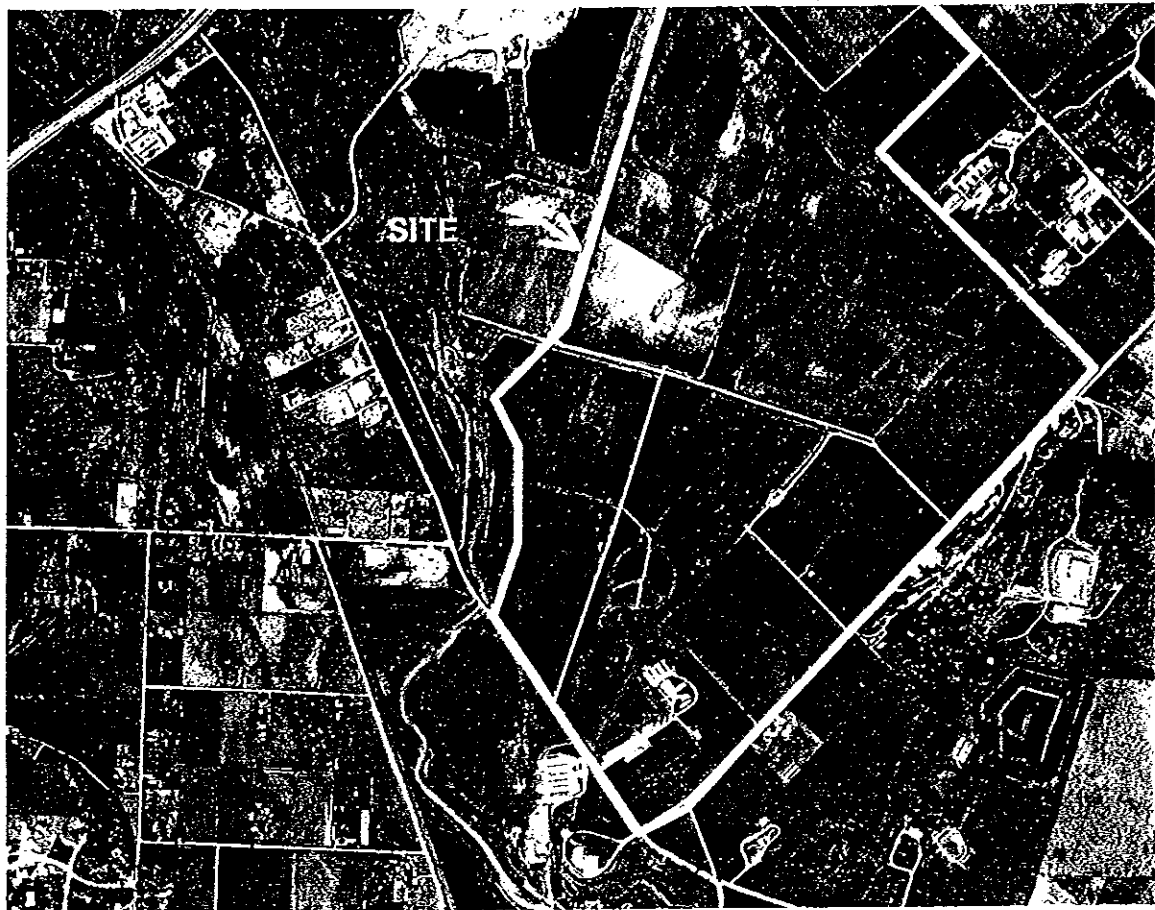
1980 Aerial Photograph

1980: No significant changes are noted to the subject property. Excavated areas at the west adjoining site have filled with water. No other significant changes are observed to adjoining sites.

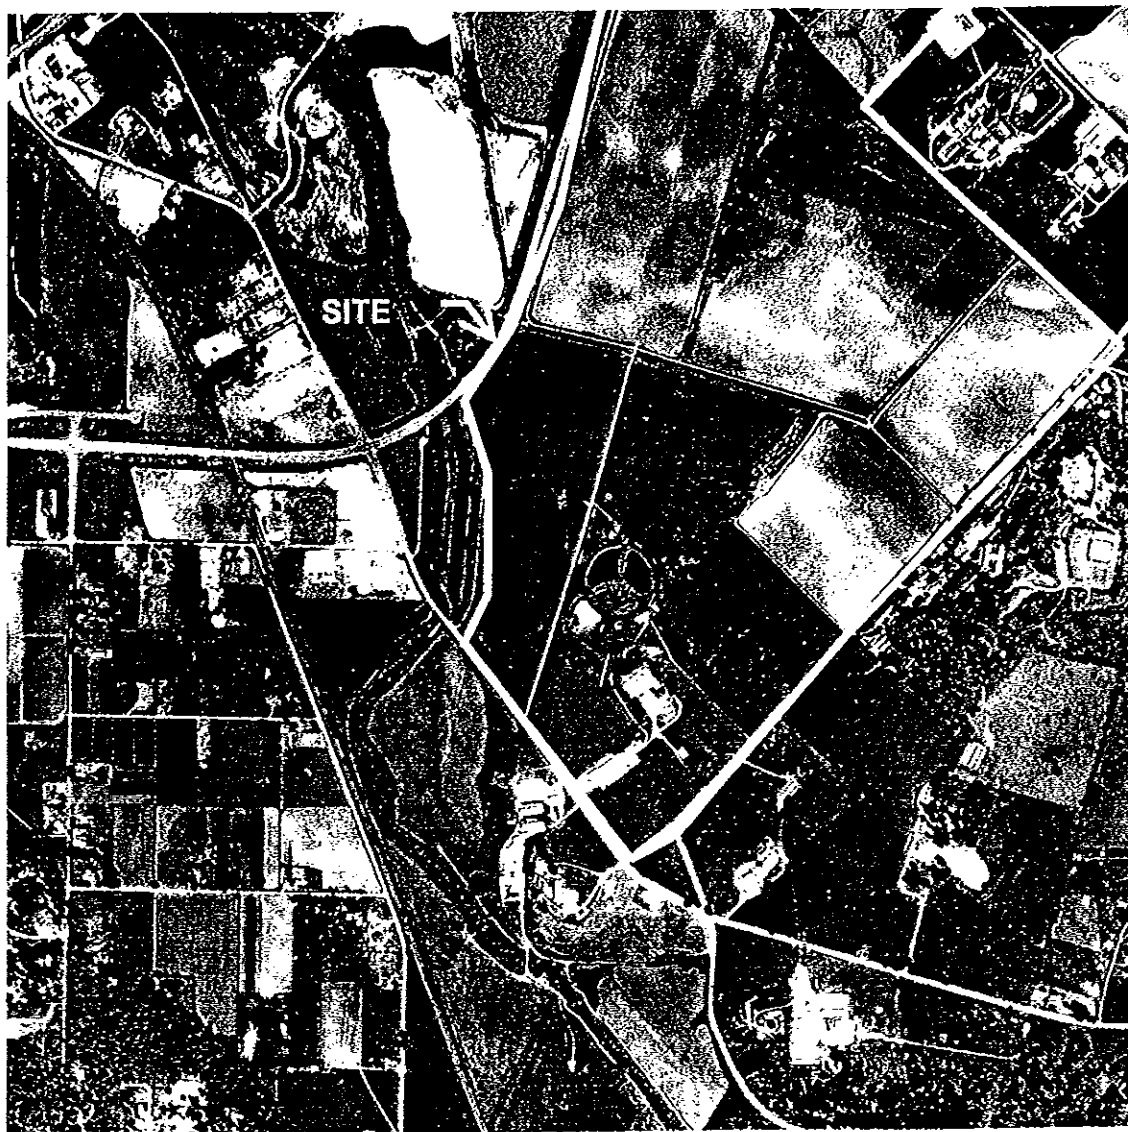
1994 Aerial Photograph

1994: A new road now bounds the west side of the property (Kuebler Boulevard). No other significant changes are noted to the subject property or adjoining sites.
