# Phase One Environmental Site Assessment

700 Acres

State of Oregon's Mill Creek District Surplus Property  
Salem, Oregon

July 2003  
Project #: 16912.000

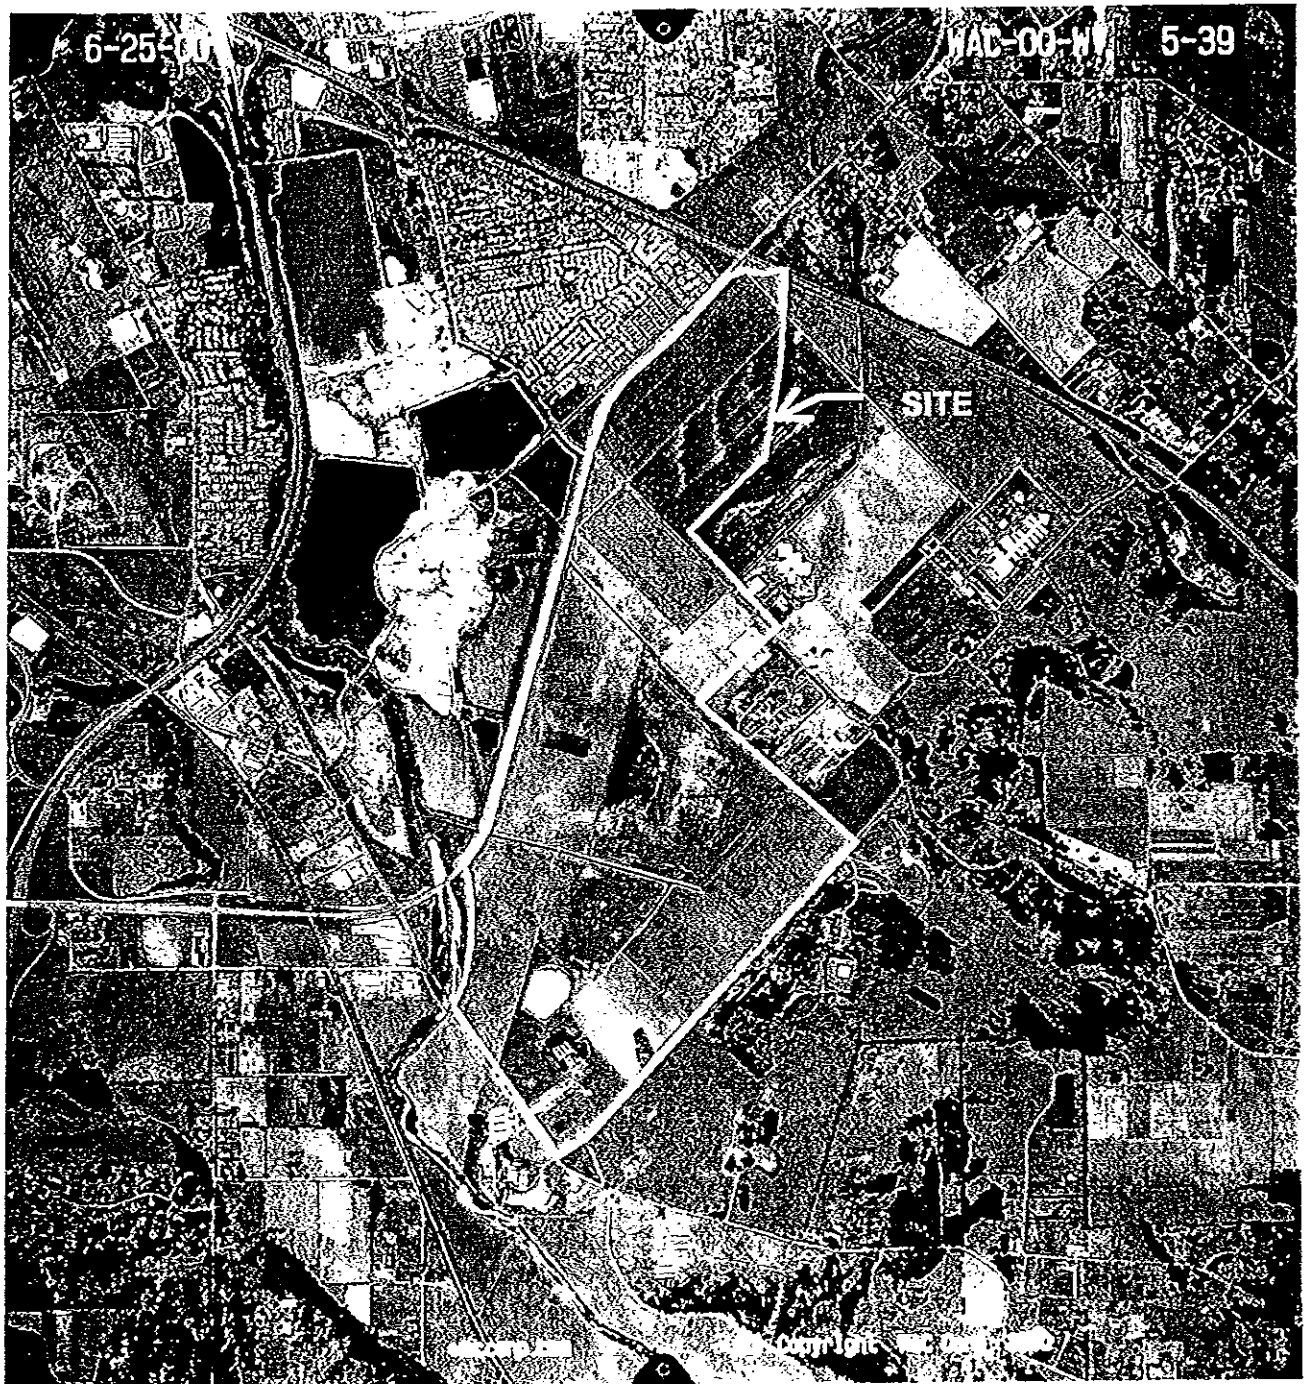
2000 Aerial Photograph

2000: The shape of the onsite pond structure north of the site buildings has changed and appears to be reduced in size. Buildings are present on the northeast adjoining property along Aumsville Highway (area not visible on previous photographs). Additional excavations filled with water are observed on the west adjoining sand and gravel site. No other significant changes are observed on the subject property or adjoining sites.
